Final Report for:
Des Plaines River Bank Stabilization
& Riverwoods Drainage Evaluation Phase I

Prepared for:
Village of Lincolnshire
One Olde Half Day Road
Lincolnshire, IL 60069-3035

October 27, 2016

5.1 Existing Conditions Berm Photos

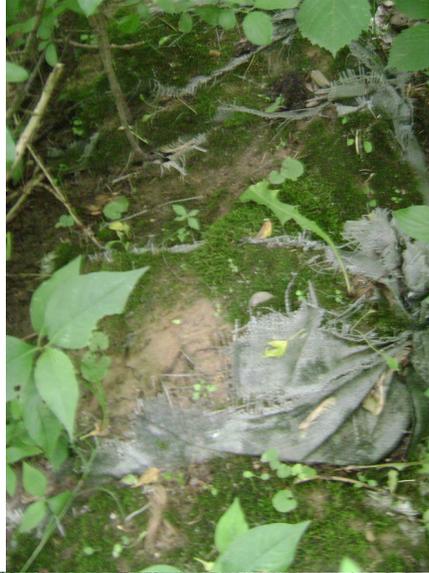
Description: Sand bags along berm crest, Sta. 97+00.

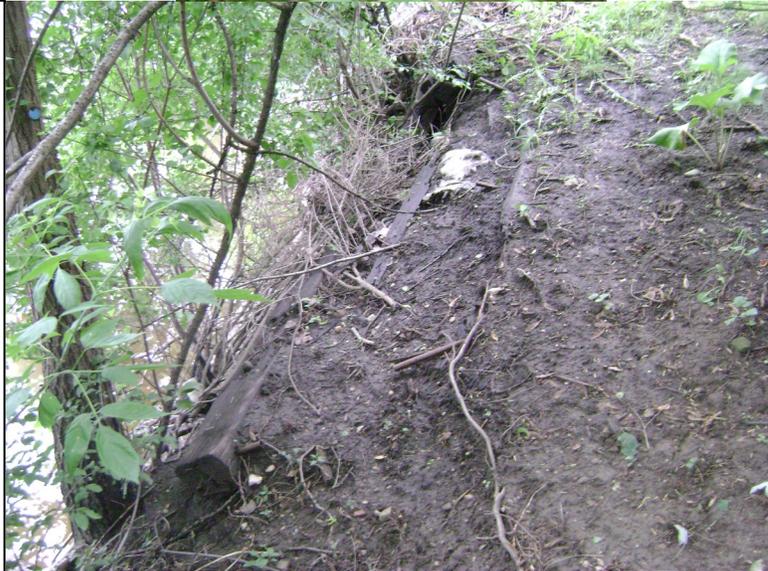
Photo 2

-
- Station 98+00 (outside of topographic survey area) – A three-tiered railroad tie terrace is present on the river-side of the berm. The railroad ties are no longer fully upright and appear to be disintegrating from moist soil conditions.

Description: Railroad ties along river-side of berm, Sta. 98+00.

Most of the deteriorating railroad ties hold back a maximum of 8" of soil, with the exception of the railroad ties at station 105+50. These railroad ties should all be removed and the area regraded to a maximum slope of 2.5' Horizontal:1' Vertical. The railroad ties from stations 104+25 to 104+50 should be removed as part of the berm material replacement at this location. The railroad tie wall surrounding the oak tree at station 106+75 holds back a large amount of soil with a big potential causing berm

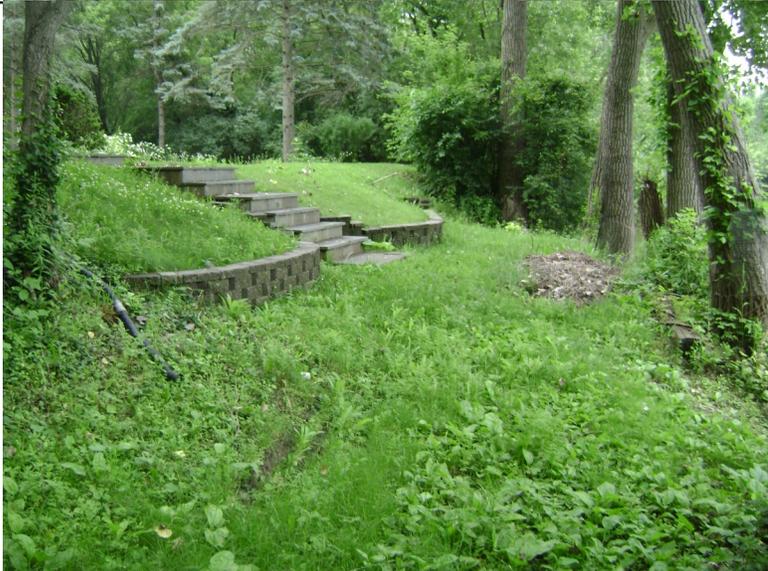
Photo 3

- Station 100+75 (53 Lincolnshire Dr.) – A concrete block wall is present on the river-side of the berm. The wall appears to be well-maintained, but may be susceptible to damage from high velocity water since the blocks are not grouted into place. However, the wall doesn't appear to reduce berm stability.

Description: Concrete stairs, block retaining wall, and railroad ties on river-side of berm, Sta. 100+80. 2" drain line over the berm crest.

failure. The wall should be removed, and the area backfilled and stabilized. The modular block walls at Station 100+75 do not require any action.

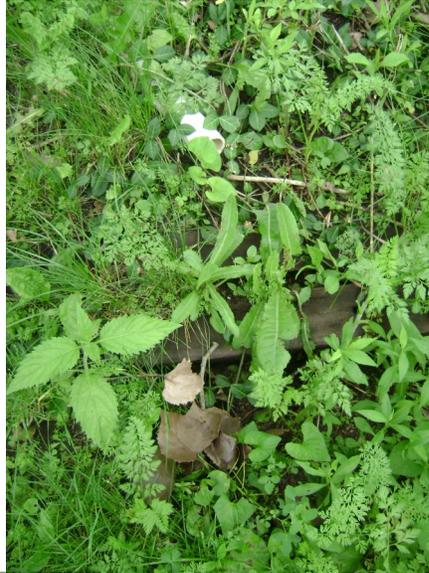
Photo 4

Description: 3" drain line penetration through berm Sta. 100+80.

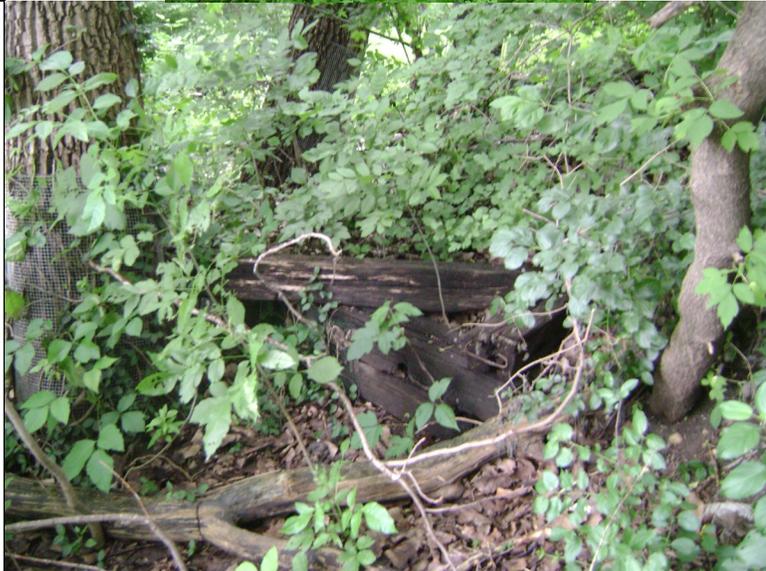
Photo 5

- Station 101+15 (53 Lincolnshire Dr.) – A railroad tie wall is present on the river-side of the berm. The top railroad tie has dislodged, and all of the ties appear to be disintegrating from moist soil conditions.

Description: Railroad ties on river-side of berm, Sta. 101+15.

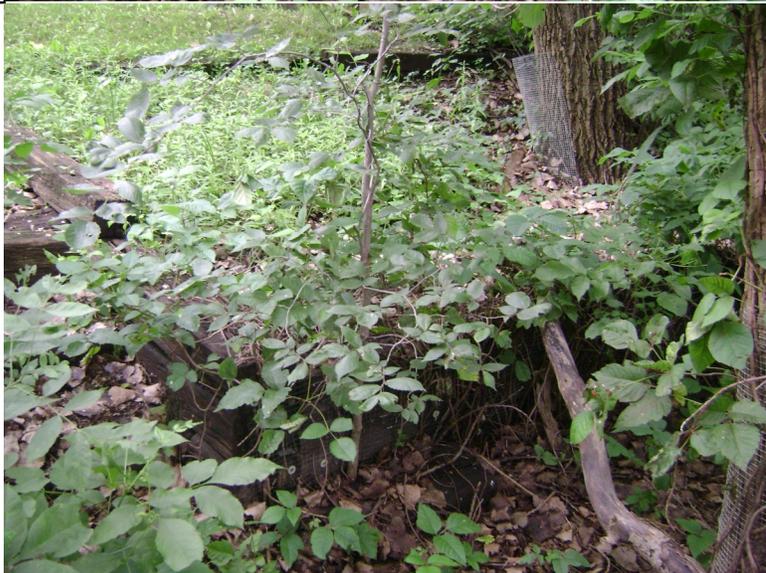
Photo 6

- Station 101+50 (55 Lincolnshire Dr.) – A railroad tie wall is present on the river-side of the berm. The ties appear to be disintegrating from moist soil conditions.

Description: Railroad ties along toe of berm slope, on river-side of berm, Sta. 101+50.

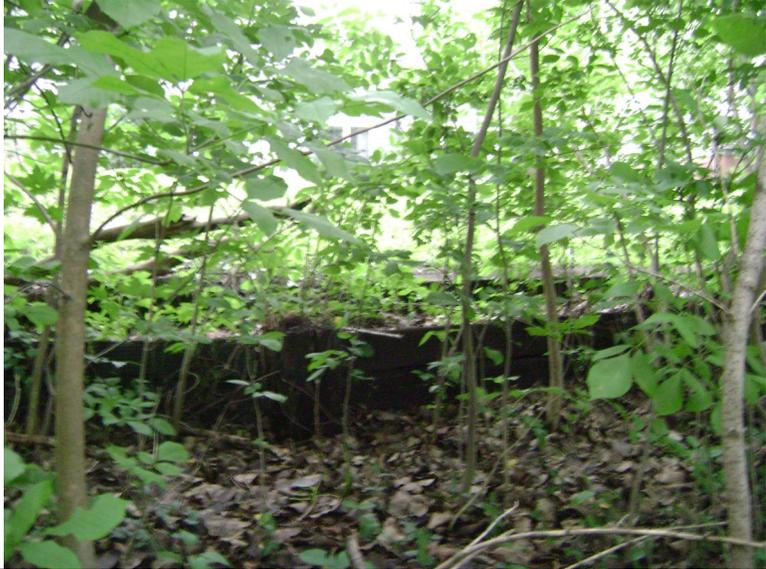
Photo 7

Description: Railroad ties along toe of berm slope, on river-side of berm, Sta. 101+50.

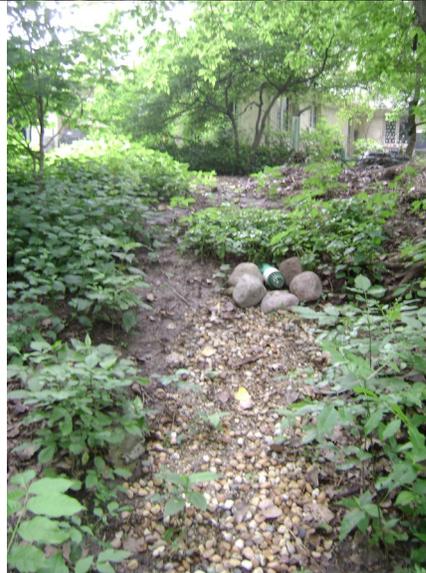
Photo 8

Description: 4" drain penetration through berm, Sta. 102+40.

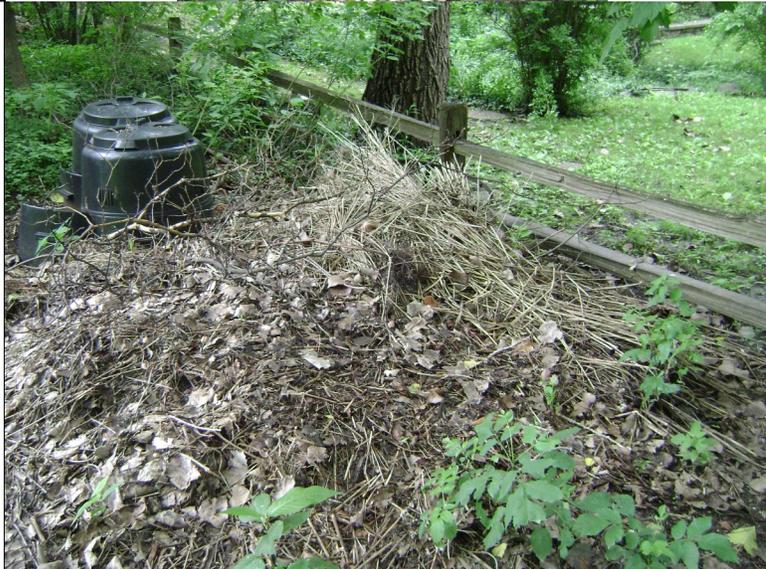
Photo 9

Description: Brush pile along berm crest, Sta. 102+35.

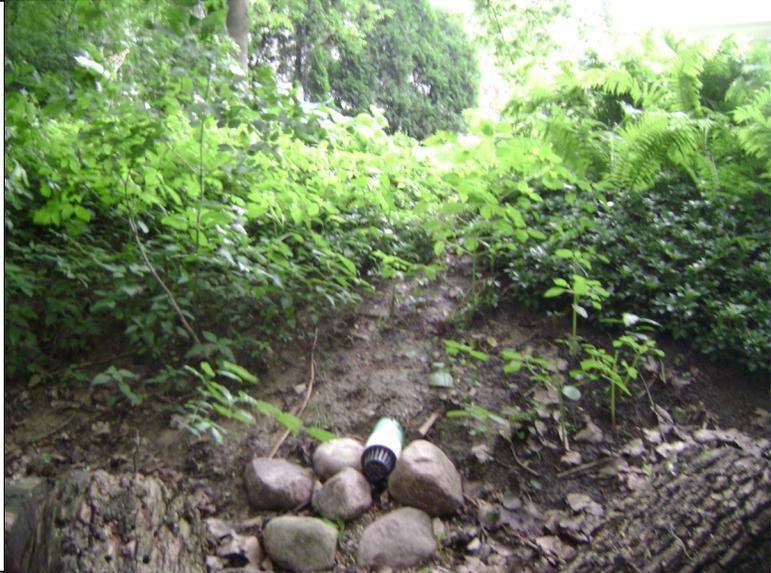
Photo 10

Description: 4" drain penetration through berm, Sta. 102+80.

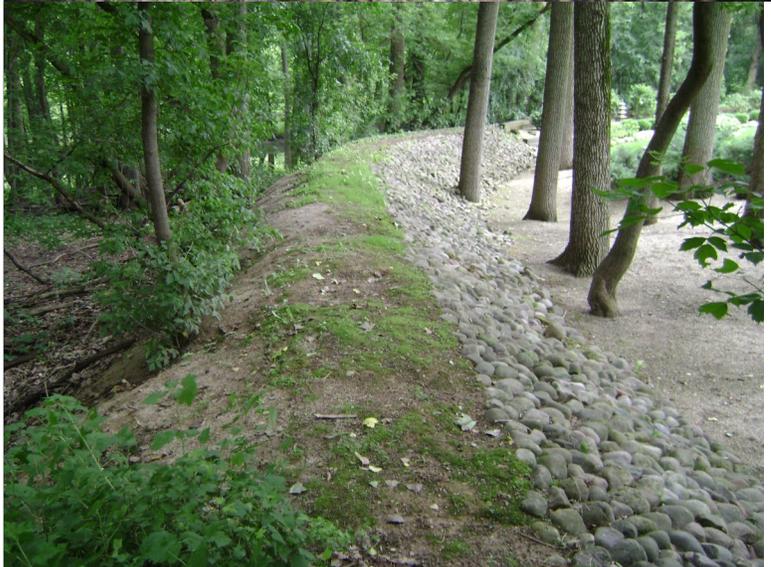
Photo 11

The berm segment from station 103+40 to 104+20 (57 Lincolnshire Dr. and 59 Lincolnshire Drive) appears to have poor stability. The visible berm in this section is made up of a sandy, gravelly material, which is very soft and has low stability. The Village has noted that this area has been very soft and unstable during previous sandbagging operations.

Description: Cobble stones on residence side of berm, sandy/gravelly and barren on river-side of berm, Sta. 103+40 - 104+20.

The replacement of materials for the berm at Station 103+40 to 104+20 is crucial, as the sandy materials are more prone to slope failure. This maintenance will require excavation of the existing materials at approximately a 5' depth, replacement with engineered fill, capping with compacted topsoil, seeding, and blanketing. This should also include widening of the berm crest to six feet.

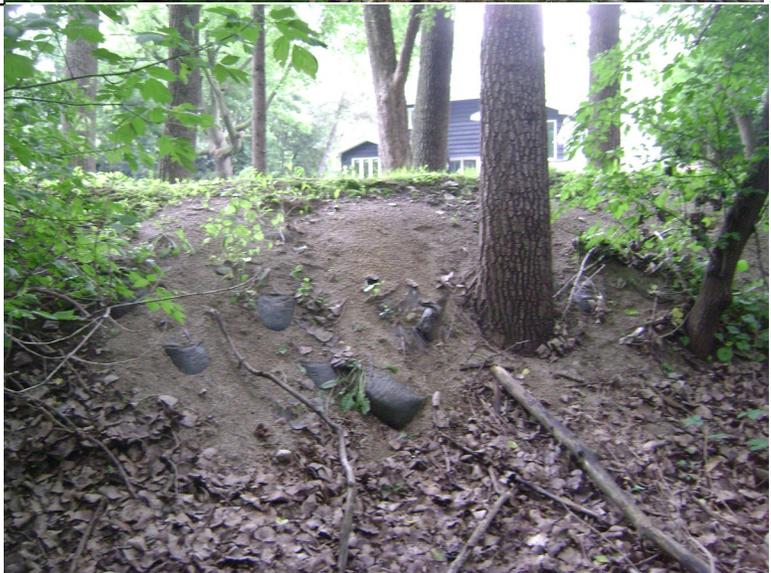
Photo 12

Description: Sandbags visible on river-side of berm, Sta. 103+80.

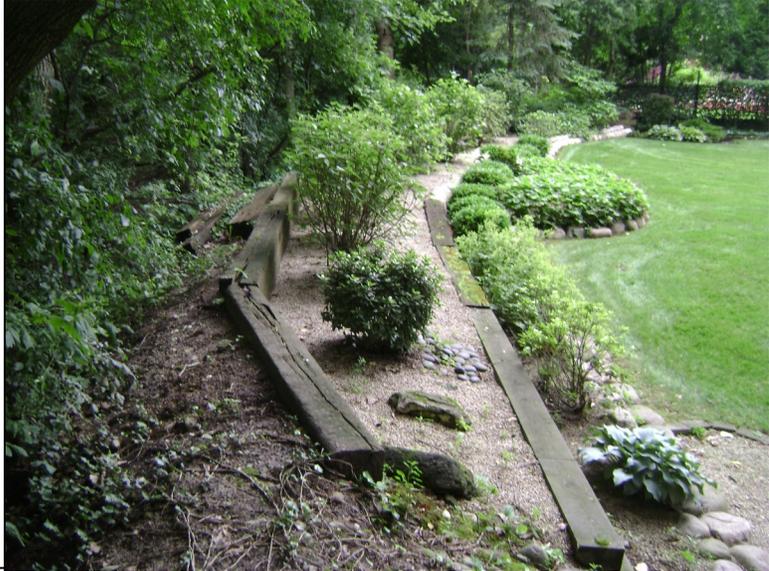
Photo 13

- Stations 104+25 to 104+50 (59 Lincolnshire Dr.) – A two-tiered railroad tie terrace is present on the residential side of the berm. The railroad ties appear to be stable but have some minor deterioration and may obstruct maintenance and emergency activities.

Description: Railroad ties and landscaping on residence-side of berm, Sta. 104+40.

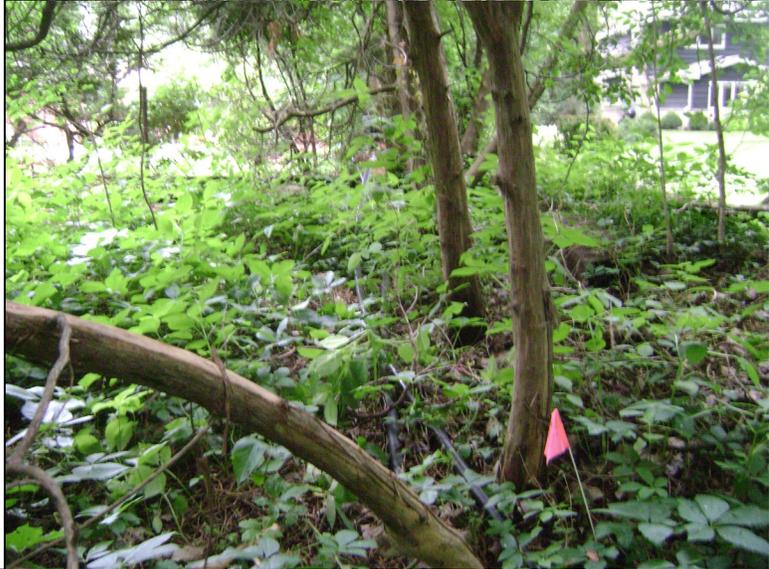
Photo 14

Description: 2" drain line running over berm crest, Sta. 104+80.

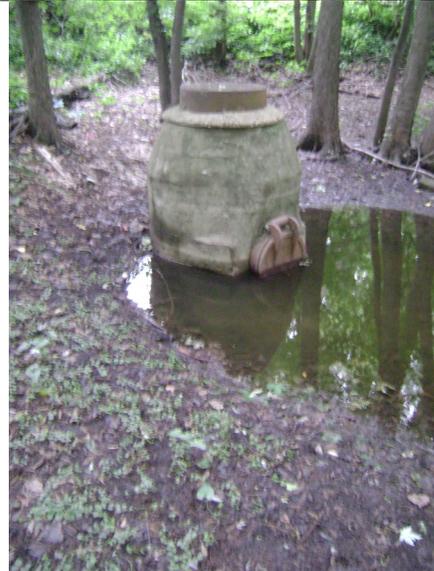
Photo 15

Description: Manhole and outlet (15") with flapgate, Sta. 104+85.

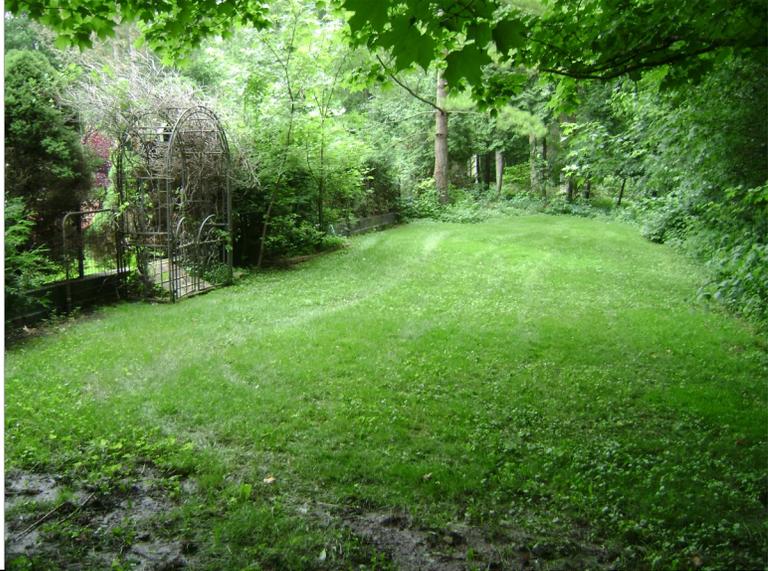
Photo 16

- Stations 105+00 to 106+20 (61 Lincolnshire Dr.) – A cinder block wall is present on the residence side of the berm crest. The cinder block wall does not provide any soil retention functions, so it is noted here solely for information purposes. The wall does not block maintenance access to the berm crest. A two-tiered railroad tie wall with metal posts and cinder blocks is present on the river-side of the berm, and appears to be deteriorating.

Description: Wide, grassy area on berm crest, cinder block retaining walls, fence, and garden structure on residence-side of berm, Sta. 105+40.

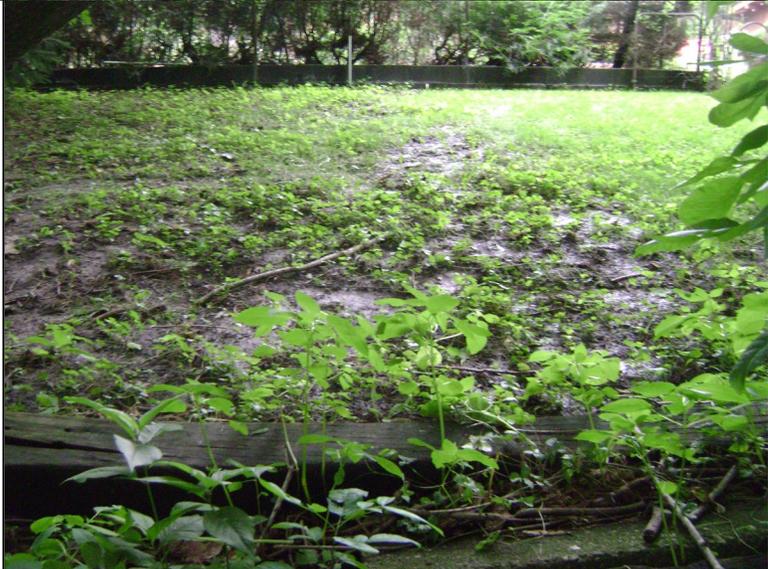
Photo 17

Description: Barren area and railroad ties on river-side of berm, Sta. 105+50.

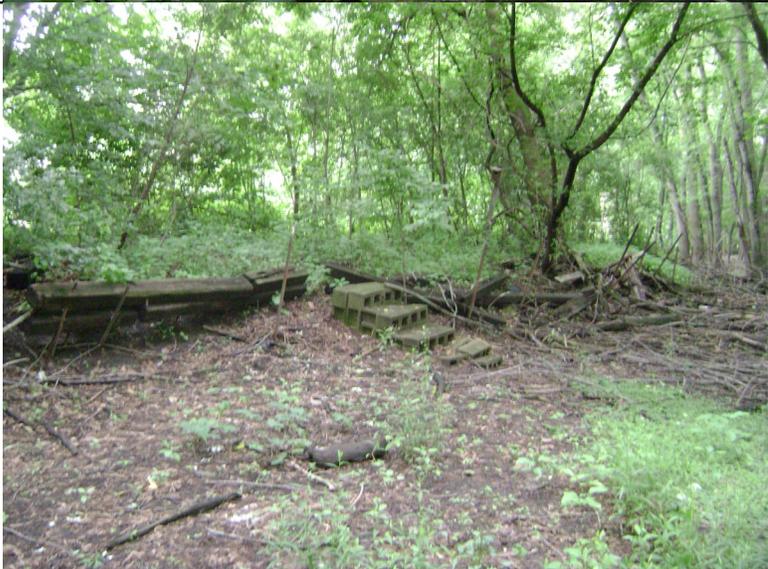
Photo 18

Description: Railroad ties, metal posts, and cinder block stairs on river-side of berm, Sta. 105+60.

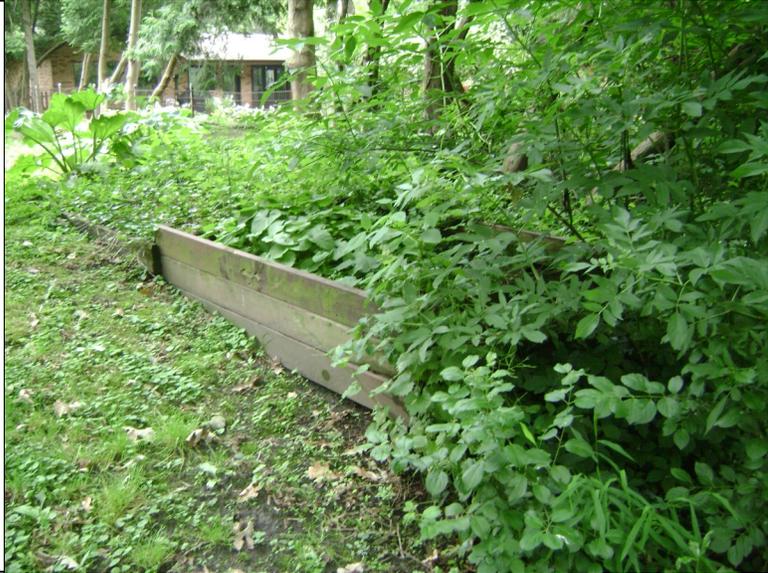
Photo 19

Description: Planter box on berm crest, Sta. 106+40.

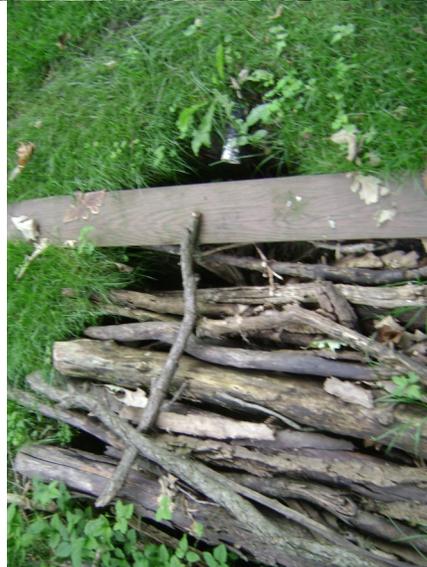
Photo 20

Description: 2" drain with woody debris and erosion penetrating through berm, Sta. 106+50.

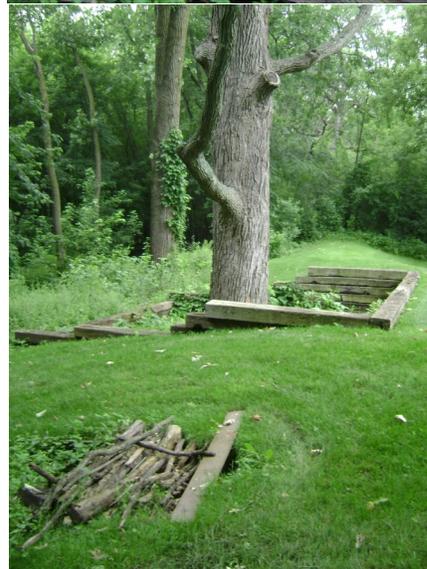
Photo 21

Description: Railroad ties around oak tree on river-side of berm crest, Sta. 106+75.

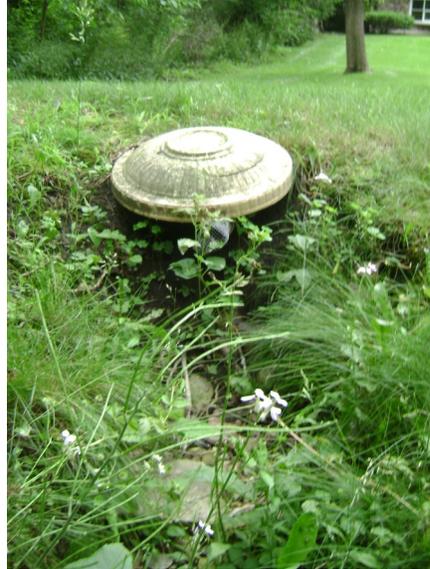
Photo 22

Description: 2" drain penetration through berm with heavy erosion, Sta. 107+40.

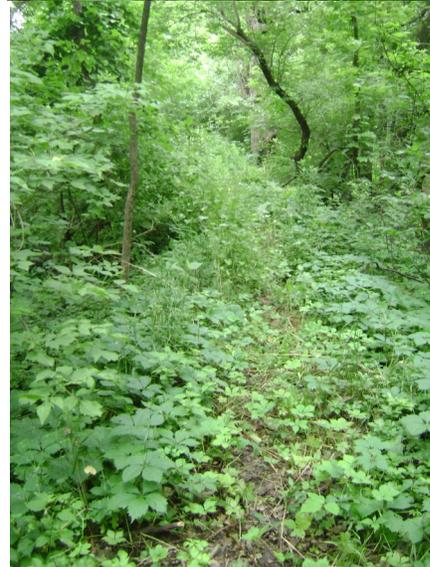
Photo 23

Description: Slight bare area/low spot along berm crest, Sta. 108+50.

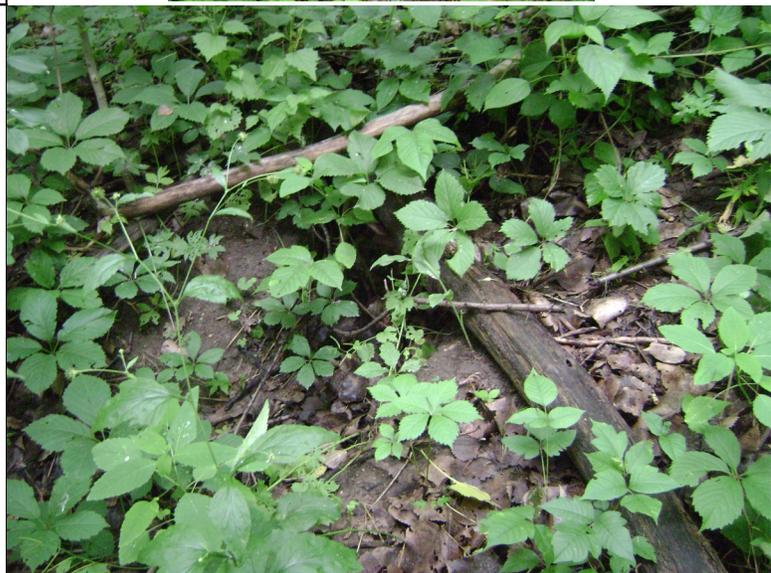
Photo 24

Description: Slightly bare/eroded area on river-side of berm, Sta. 112+85.

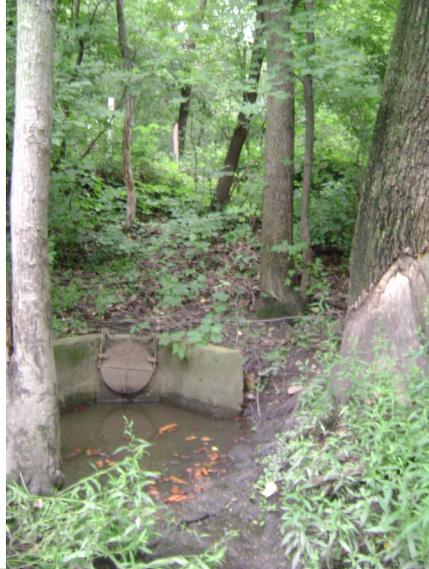
Photo 25

Description: 12" outlet pipe with concrete wingwalls and flapgate, Sta. 112+90.

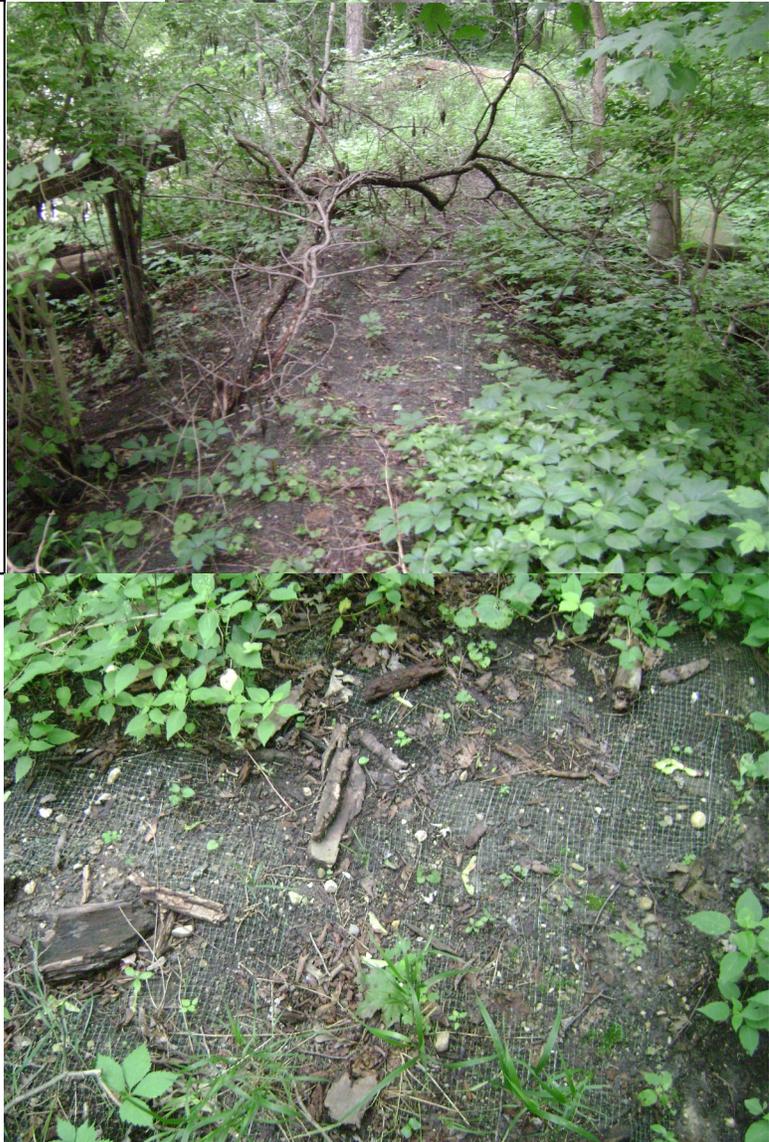
Photo 26

Description: Bare and narrow berm crest with debris, Sta. 114+10.

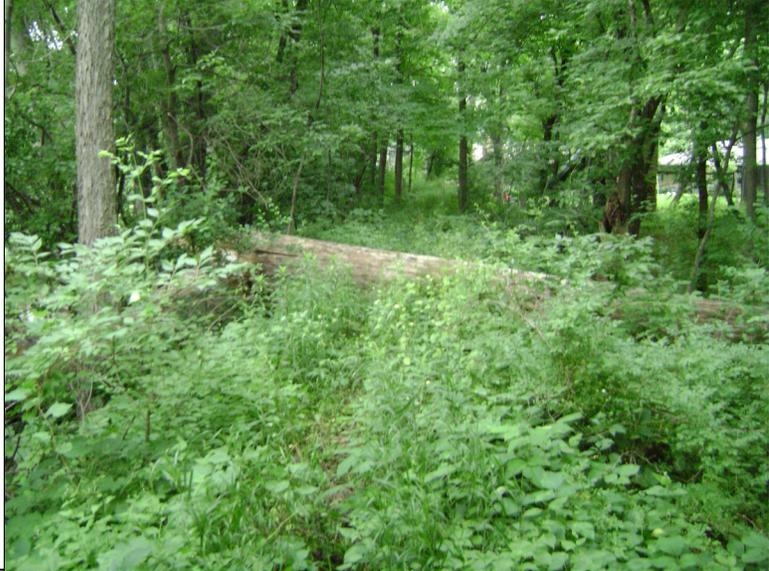
Photo 27

Description: Large downed tree over berm crest, Sta. 114+45.

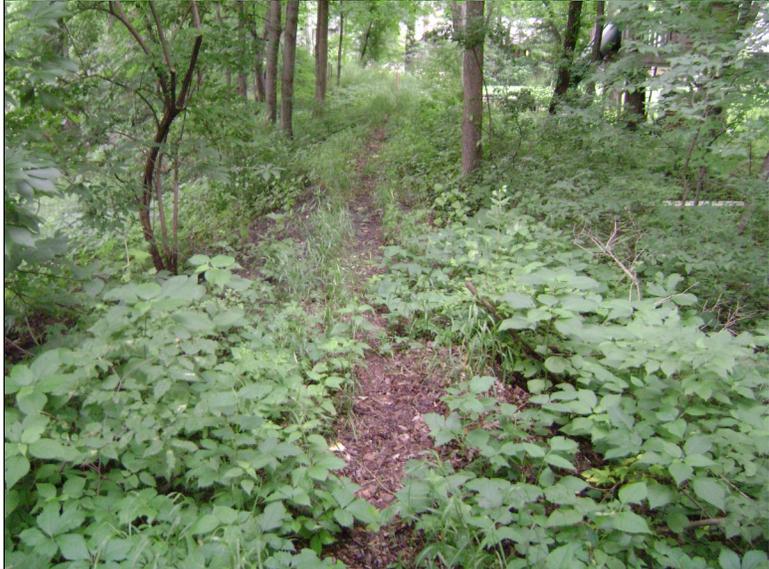
Photo 29

Description: Minor barren and narrow area, Sta. 115+10.

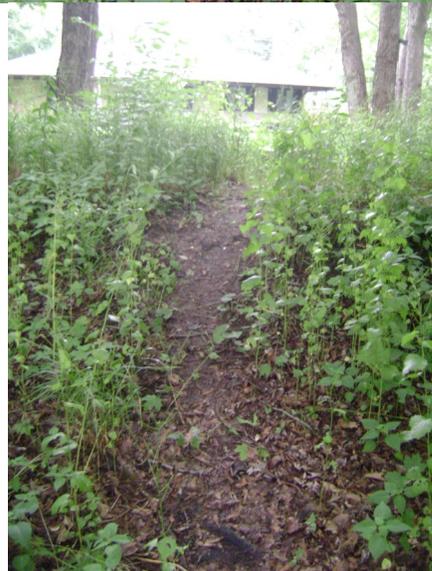
Photo 30

Description: Barren path likely from pedestrian traffic, Sta. 115+40.

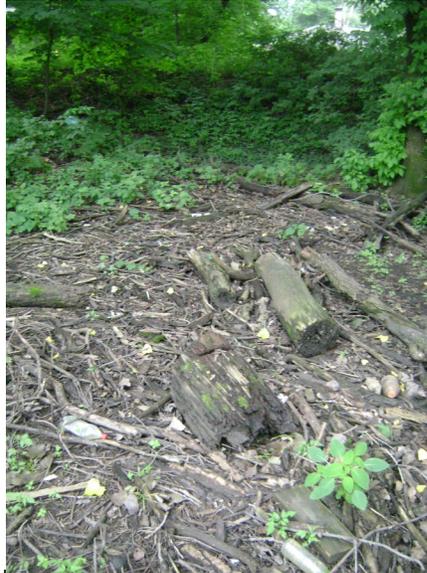
Photo 31

Description: Substantial debris present at toe of slope on river-side of berm, Sta. 116+40.

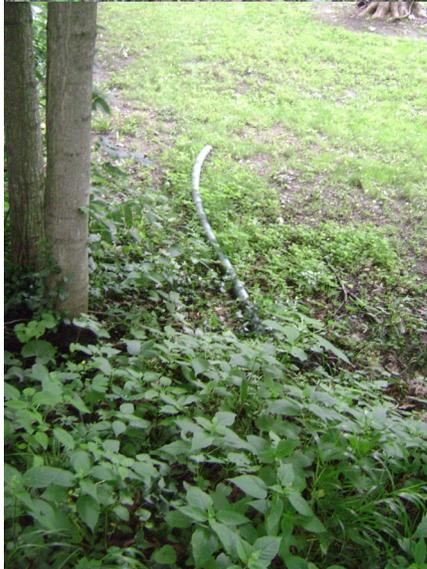
Photo 32

Description: 3" drain penetration through berm, outlet for drain on river-side not found, Sta. 117+50.
